DEVELOPMENT OF A FAIL SAFE DESIGN OXIDATION
RESISTANT REINFORCED CARBON SYSTEM FOR THE WING
LEADING EDGE OF A SPACE SHUTTLE VEHICLE

PHASE III FINAL REPORT
VOLUME II TECHNICAL

VSD REPORT NO. T143-5R-30008

JUNE 1973

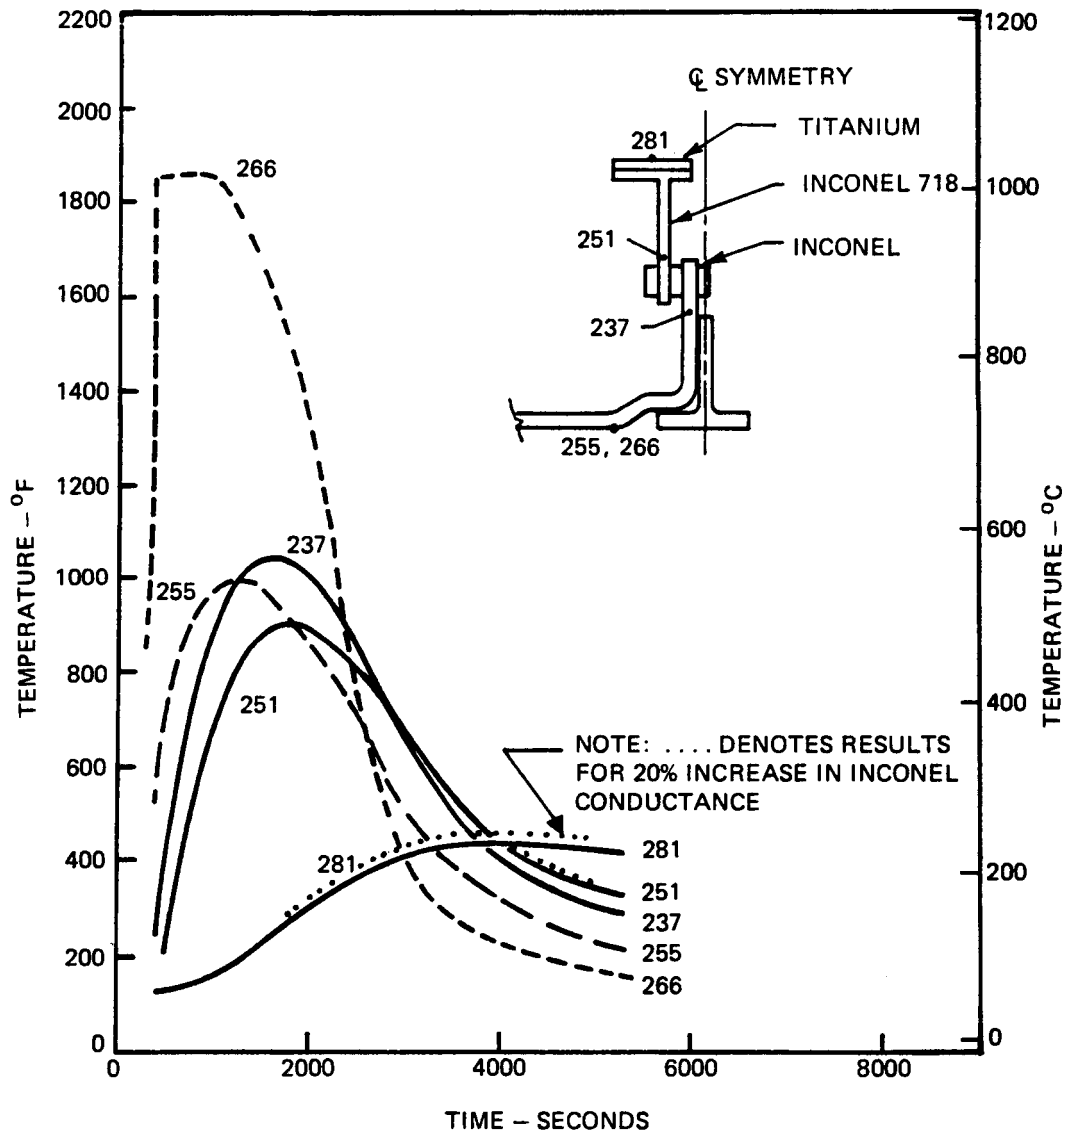
FIGURE 36 PREDICTED TEMPERATURES LEEWARD SIDE LUG AREA

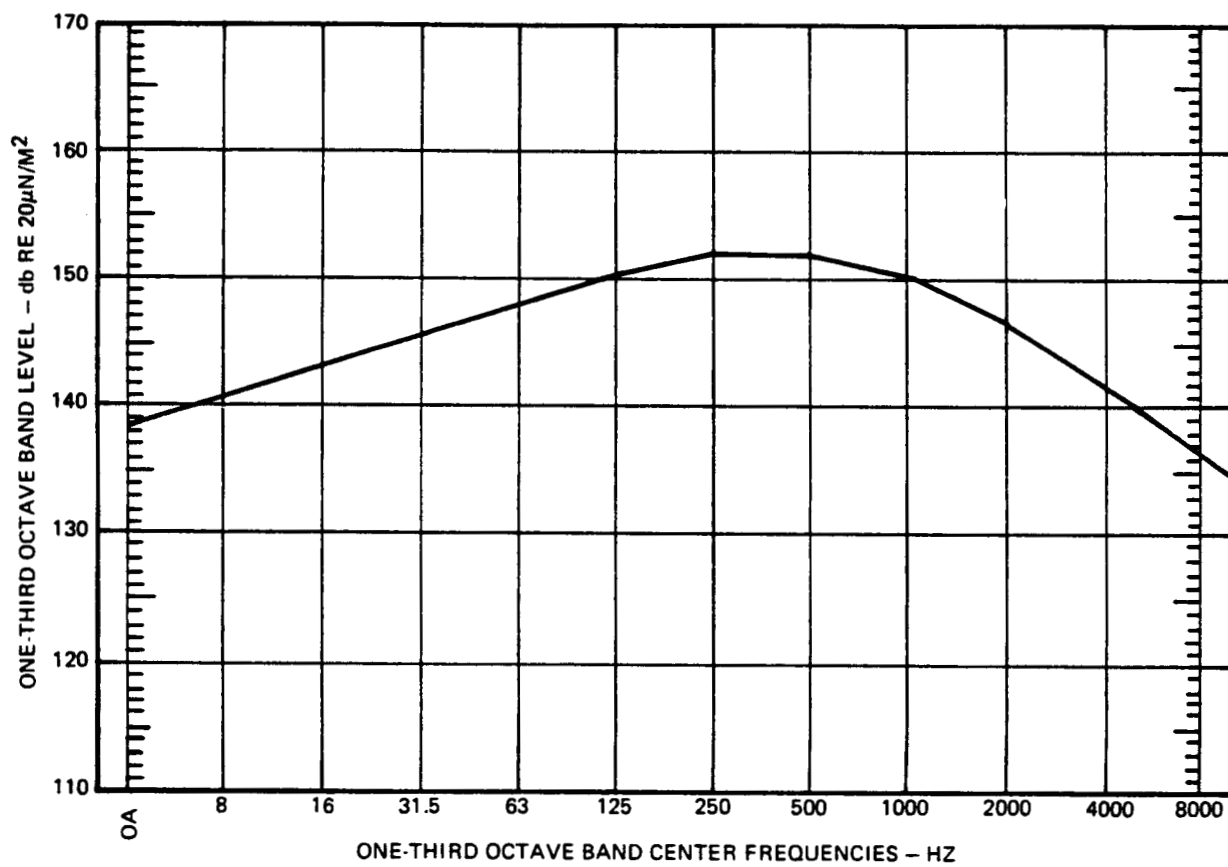
FIGURE 38 ACOUSTIC ENVIRONMENT

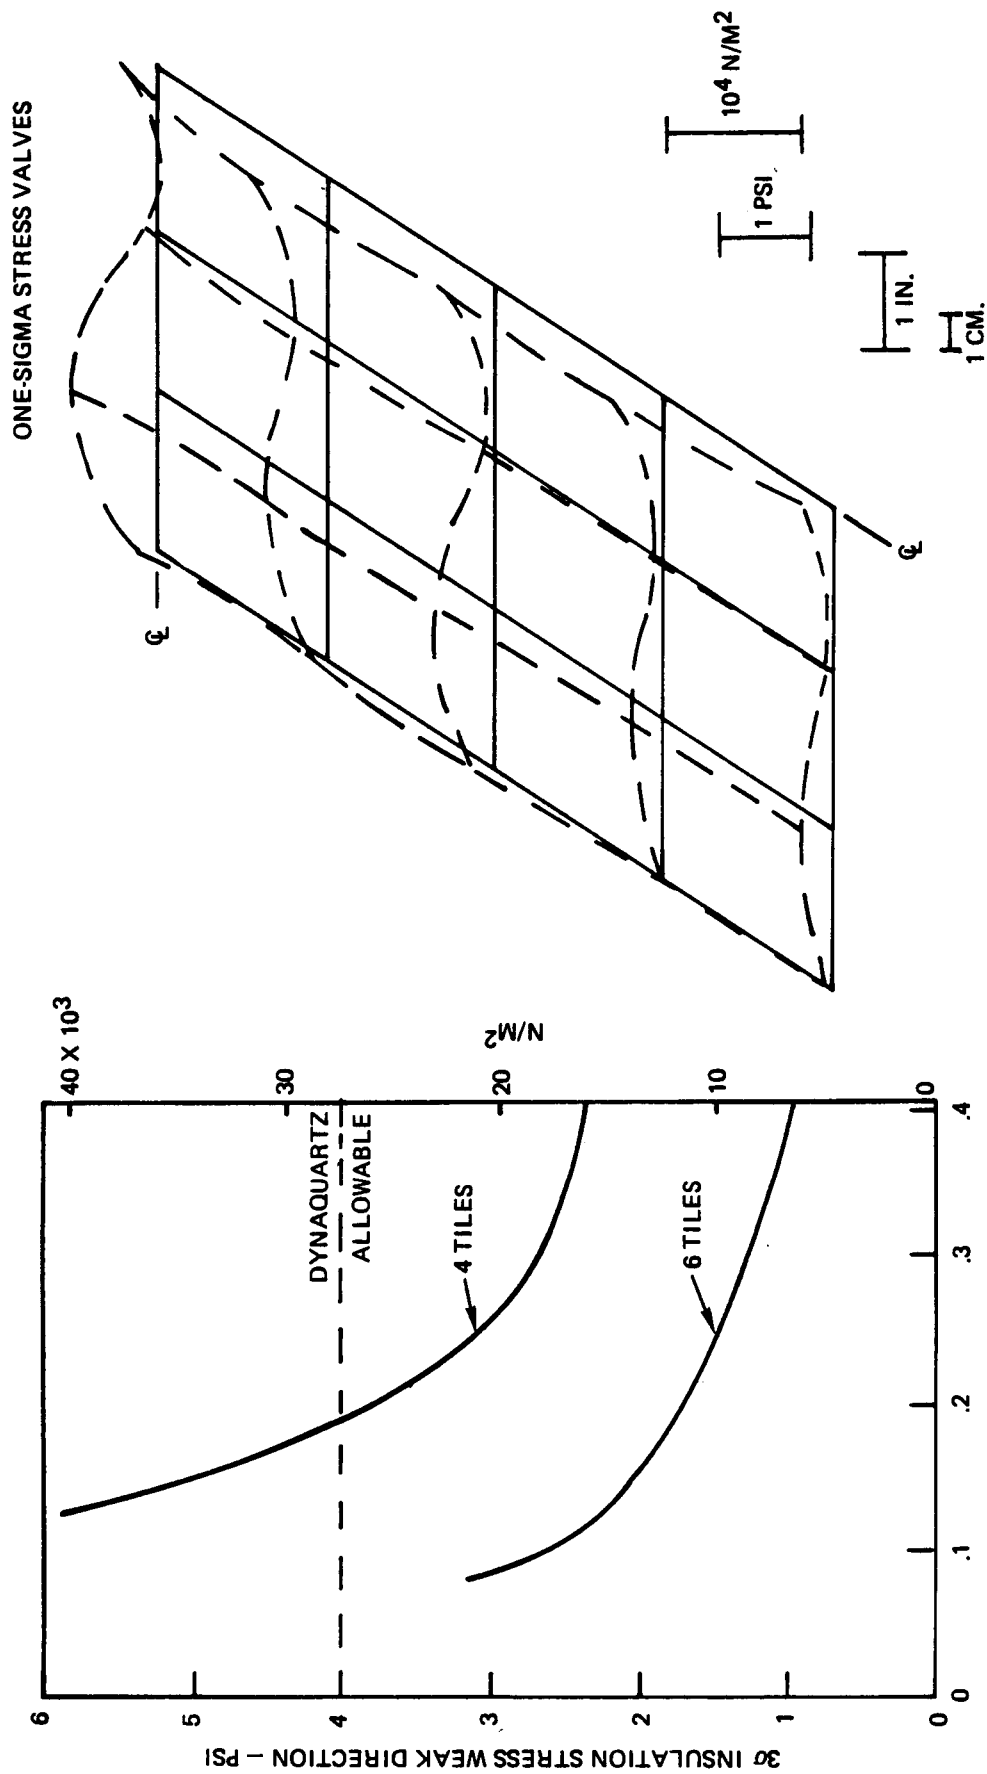
FIGURE 41 EFFECTS OF ISOLATOR THICKNESS AND NO. OF TILES ON INSULATION PEAK STRESS - CANTED HEATSHIELD

Strain isolator thickness and tile size were established from dynamic analyses, using a 32 g-rms response limit. These analyses are discussed later (Section 1.1.1.4), but they evaluated different numbers of tiles and different strain isolator thicknesses to arrive at a suitable arrangement that would limit interlaminar tensile stresses, primarily induced from support panel flexure, within material capability. However, as will be discussed later, Dynaquartz failure in a vibration test occurred from fatigue and therefore apparently at a stress level below the 3-sigma value computed. A subsequent vibration test with several modifications (Task 2) ultimately passed the vibration test. This was a demonstration to show that a rigid insulation approach could be designed to meet design dynamic load environments.

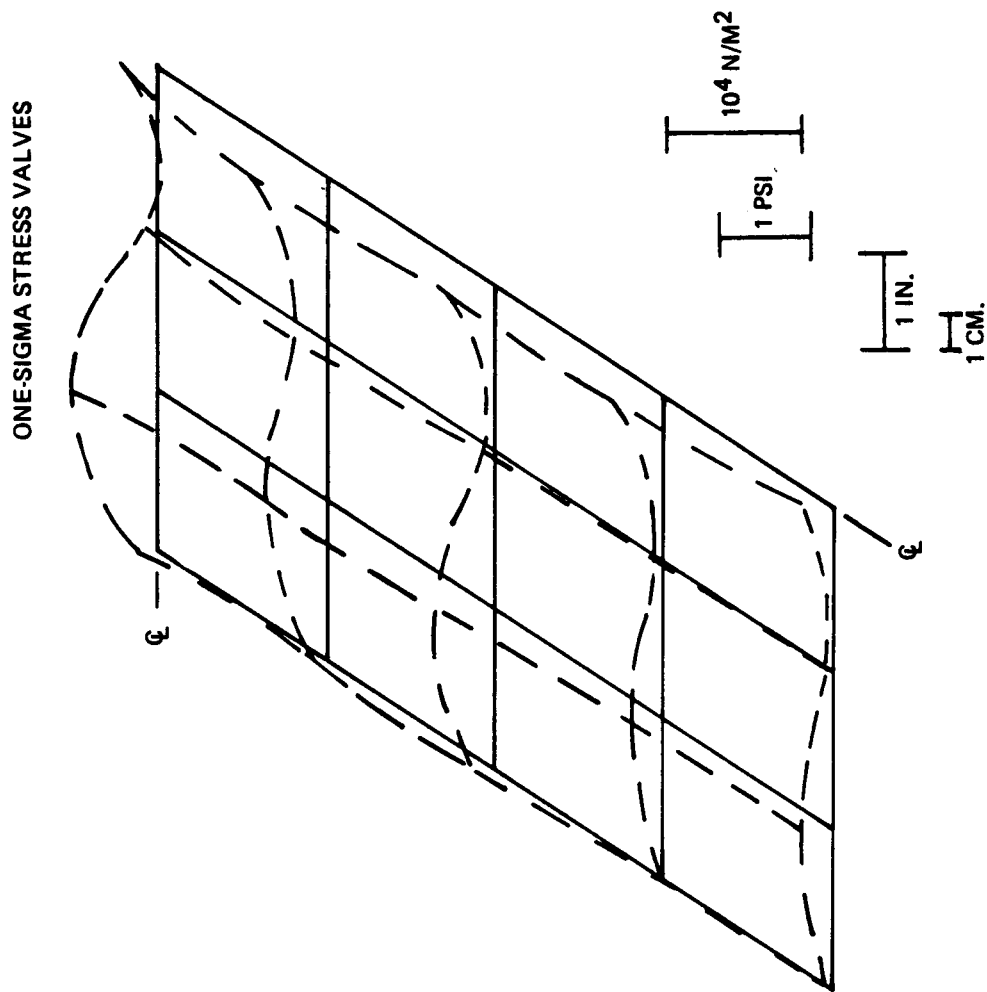
FIGURE 42 INSULATION STRESS DISTRIBUTION - CANTED HEATSHIELD - WEAK DIRECTION

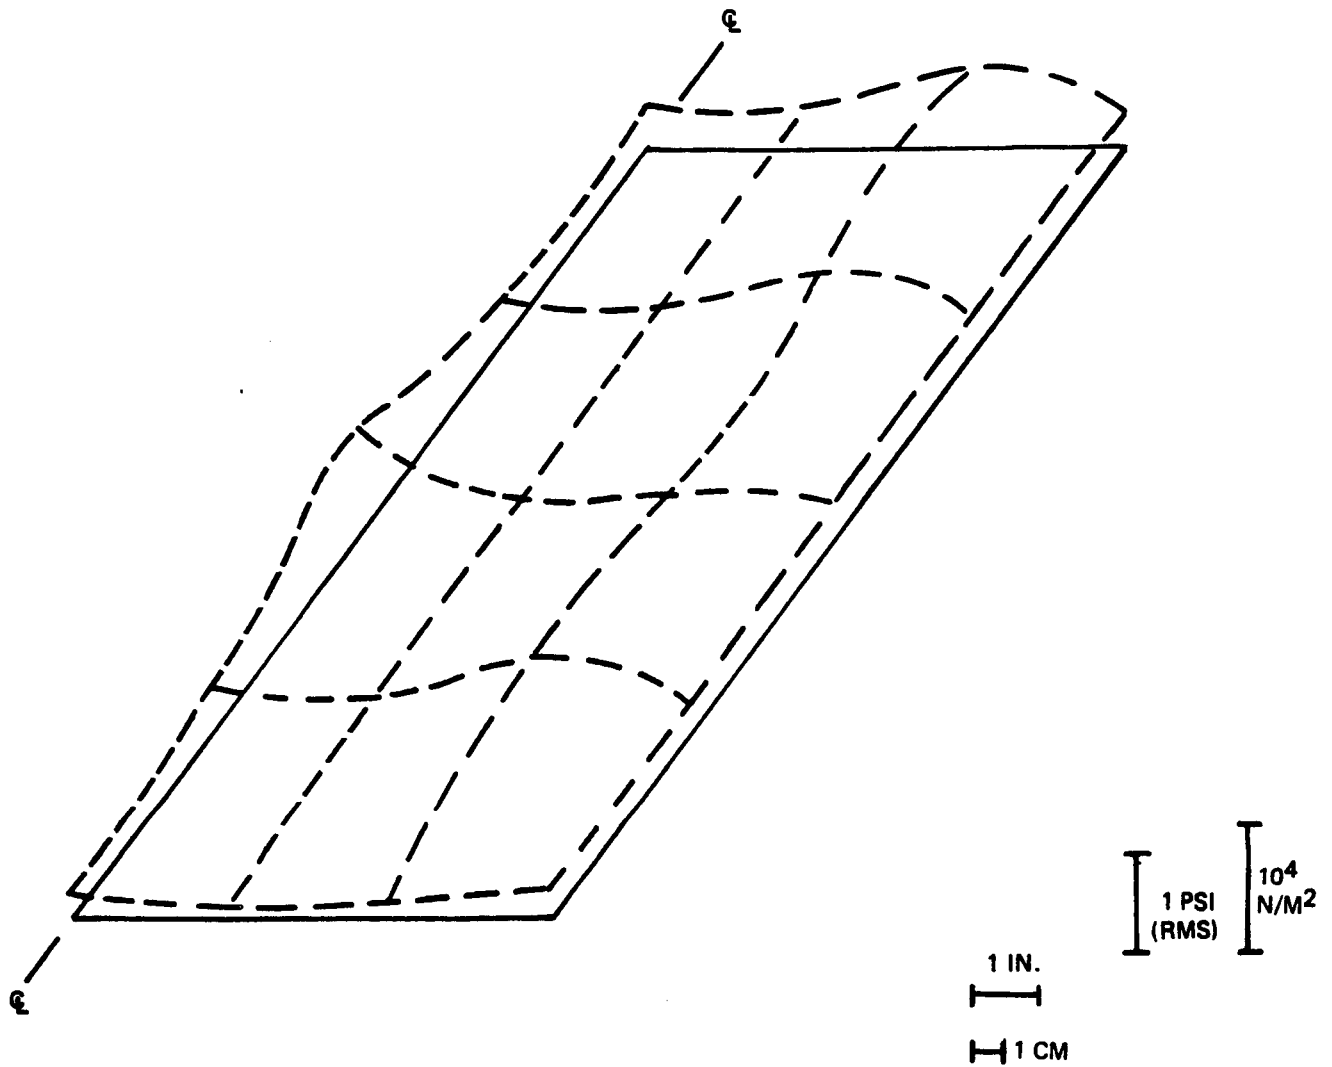
FIGURE 43 UPPER ACCESS PANEL DISTRIBUTION OF STRESSES IN DYNAQUARTZ (WEAK DIRECTION)

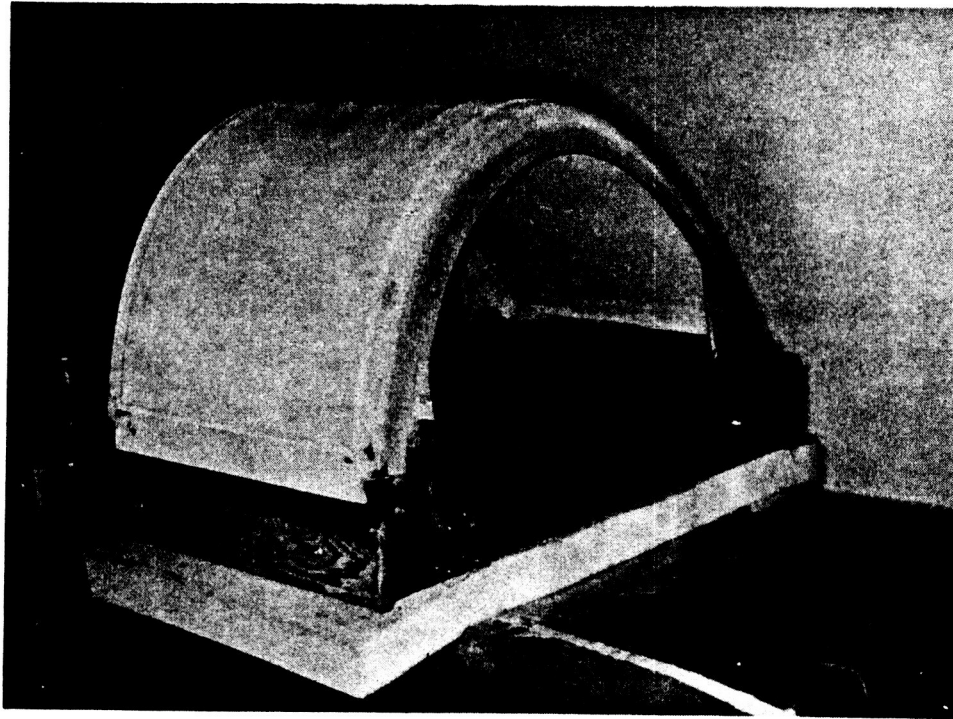
FIGURE 44 ACOUSTIC TEST LEADING EDGE AND TEST FIXTURE

In the first test, which was applied for a total of 50 minutes to simulate 100 missions at the 163 db OA level, the support holes were damaged. Enlargement of the chamfered holes was observed and minor chipping, not exposing bare RPP, was in evidence on the fixed side of the leading edge. A countersunk hole is shown in Figure 46 after test to indicate the type of damage. The countersunk holes are located on the left side of the leading edge (looking forward) and are free to float to accommodate thermal expansion (reference Figures 1 and 4). The countersunk holes enlarged during test from an initial diameter of 0.60 inch to a final

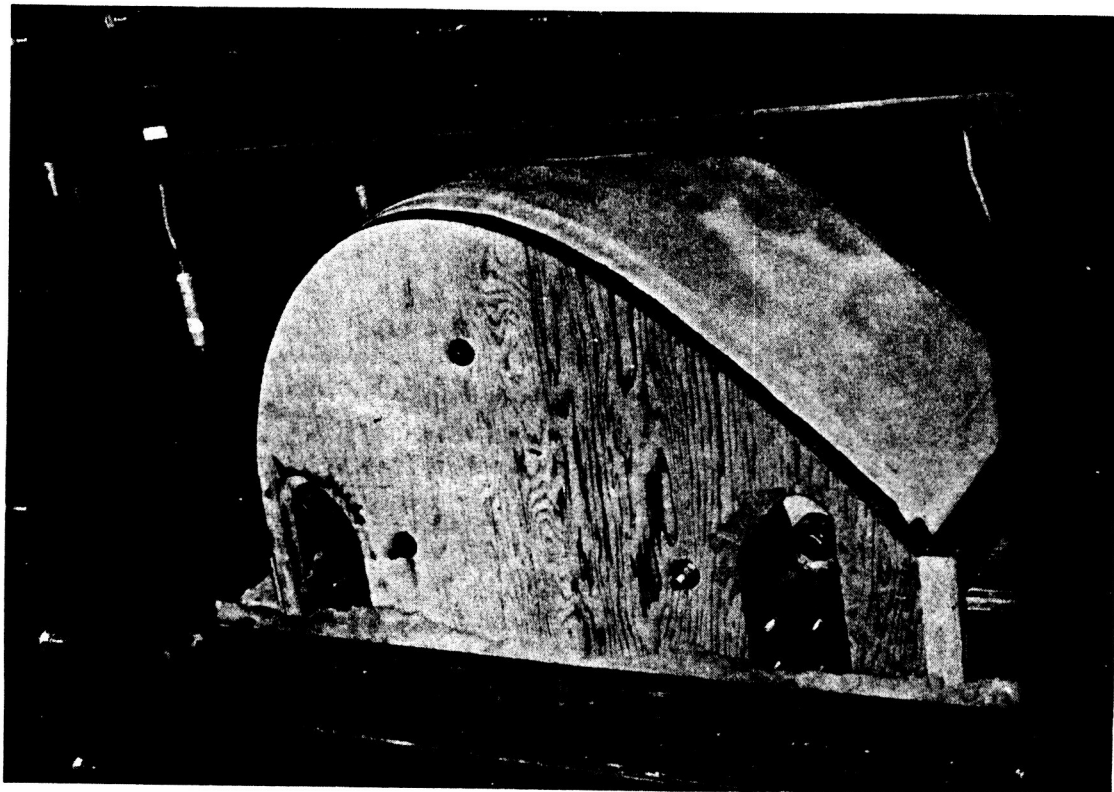
FIGURE 45 ACOUSTIC TEST LEADING EDGE INSTALLED IN PROGRESSIVE WAVE FACILITY

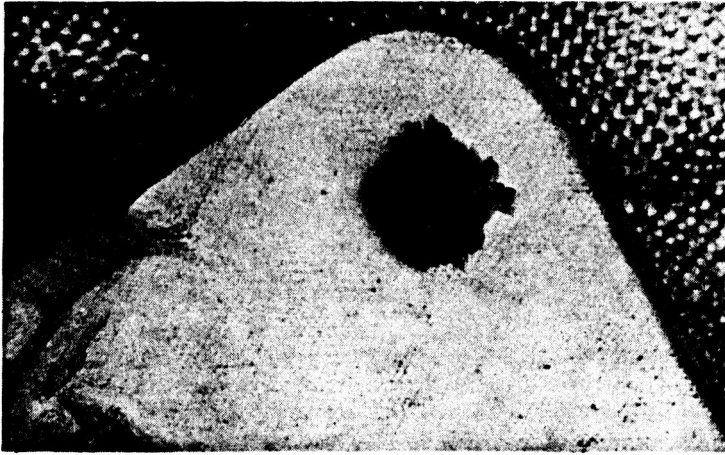
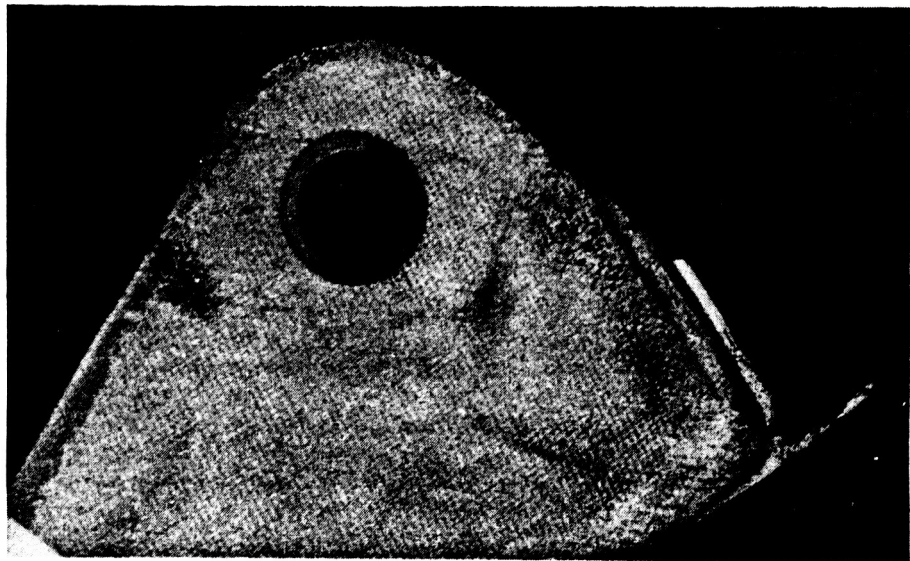
A. INNER SURFACE

B. OUTER SURFACE

FIGURE 46 HOLE DAMAGE AFTER ACOUSTIC TEST – COUNTERSUNK “FLOATING” SIDE

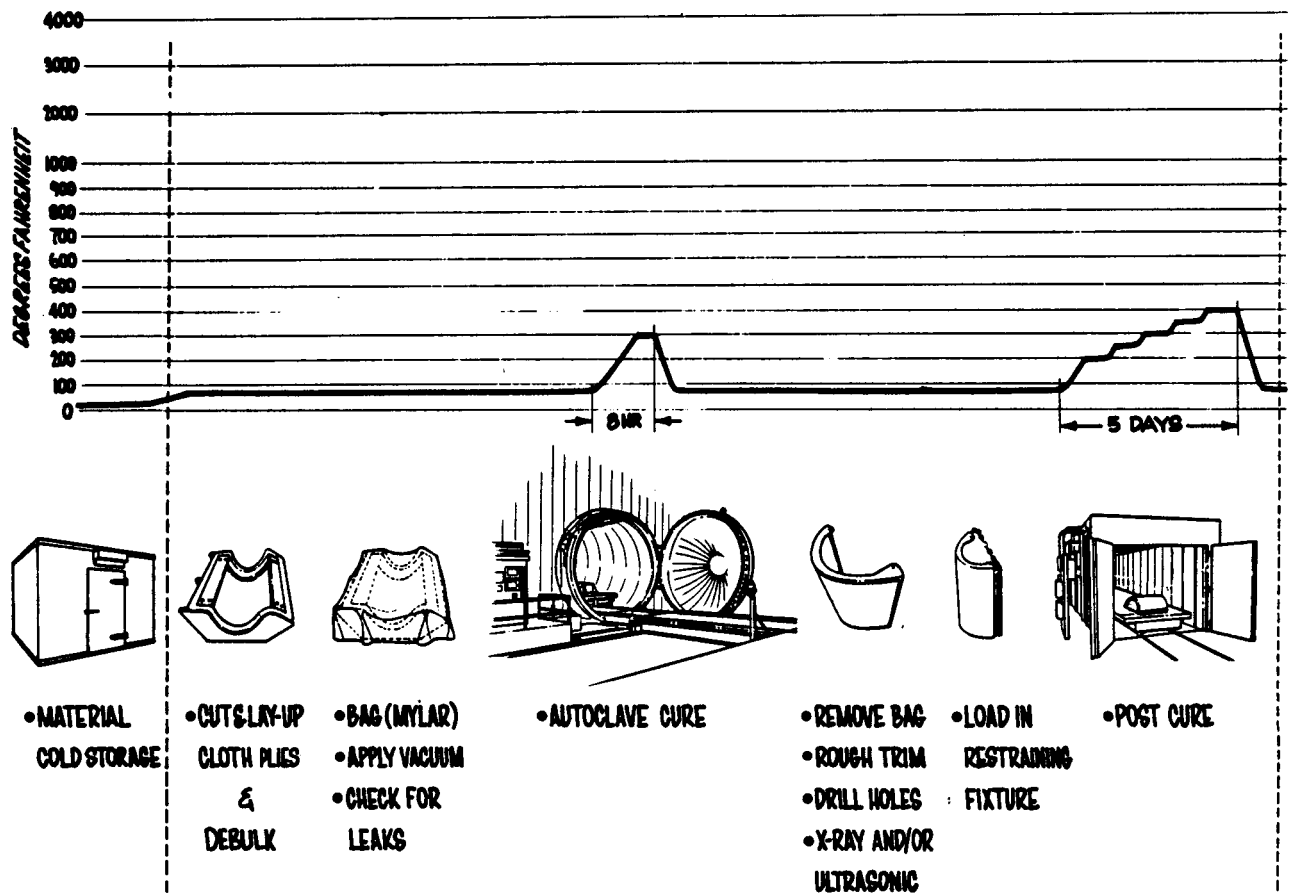
FIGURE 49 PROCESS SEQUENCE FOR COATED RPP

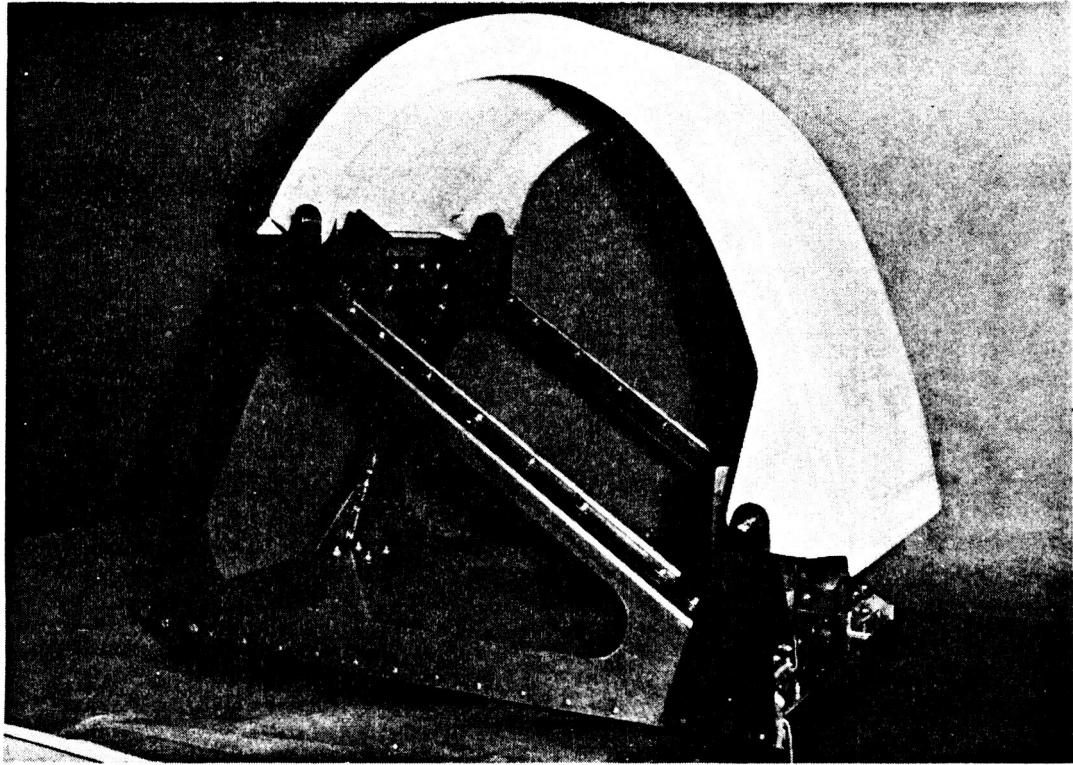
FIGURE 53 SUPPORT STRUCTURE AND RPP PAN

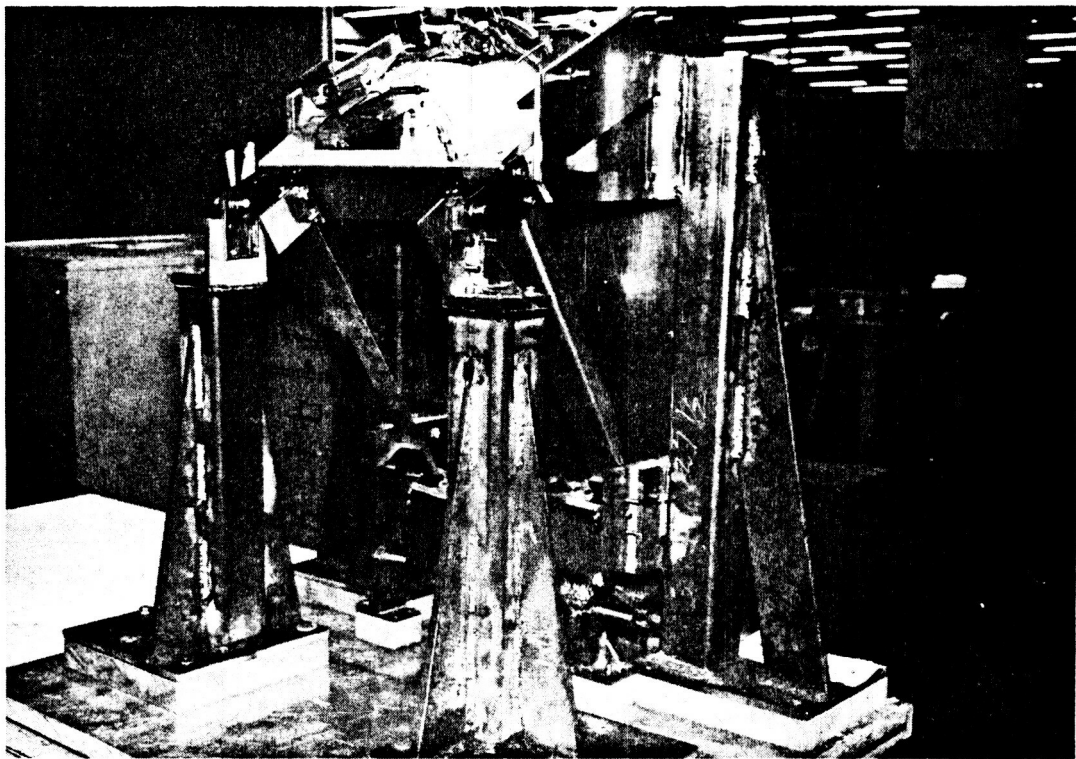
FIGURE 54 ASSEMBLY FIXTURE WITH SUPPORT STRUCTURE IN BUILD-UP STAGE

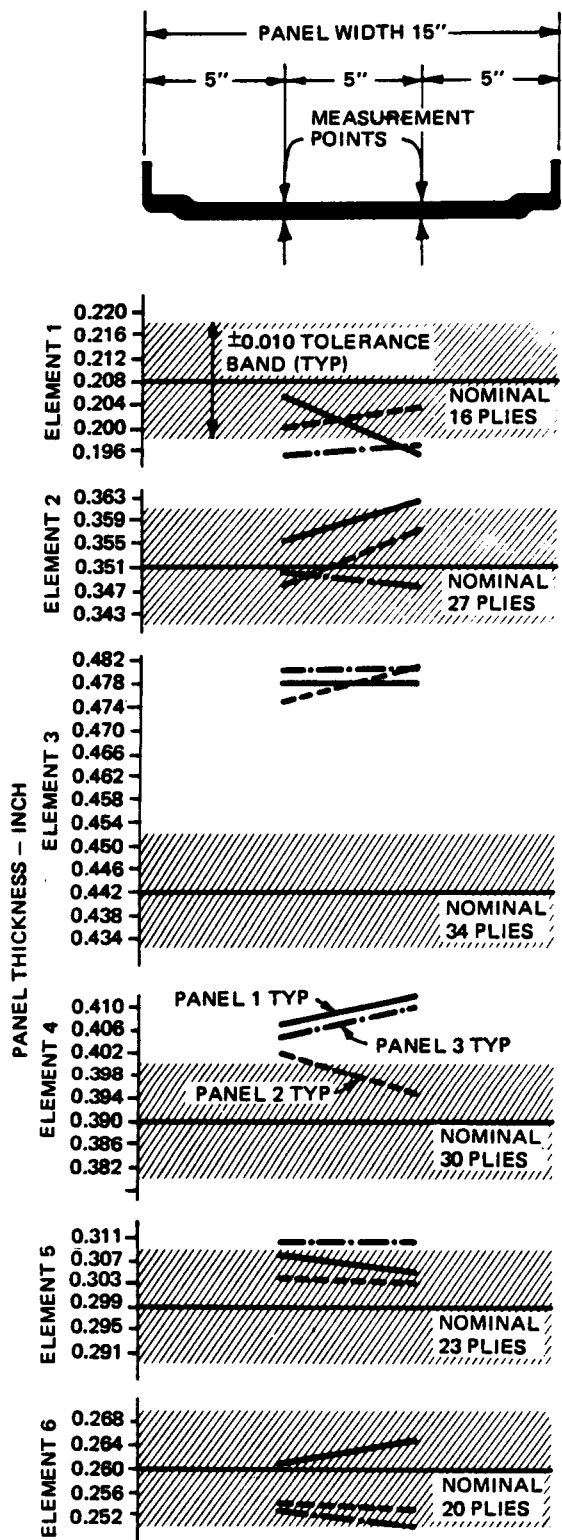
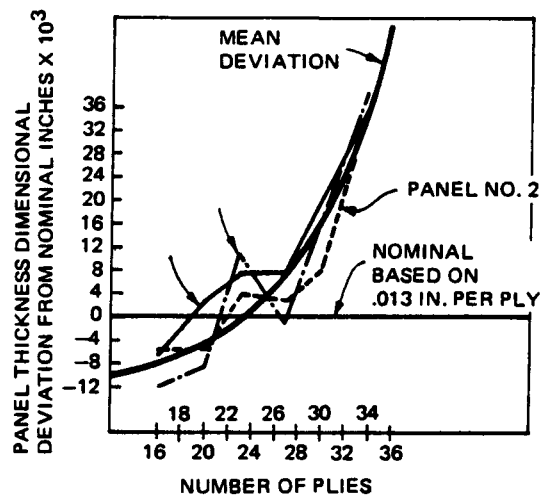
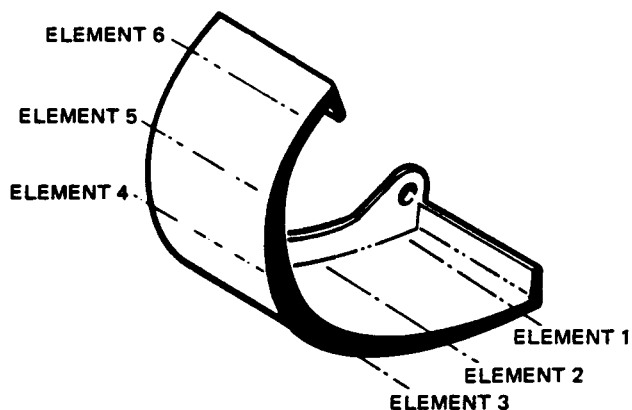
FIGURE 56 PANEL THICKNESS TOLERANCE AND MEASUREMENTS - COATED CONDITION

Upon completion of fabrication, measurements were made of all three panel thicknesses taken at six surface element lines described in Figure 56. Thickness measurements were plotted to highlight deviations from a nominal thickness dimension computed on the basis of a nominal 0.013 inch per ply allowance. Examination of the data in Figure 56 shows that it is unrealistic to assume an 0.013 inch per ply dimension for calculating build-up over such a large range of thicknesses making up the Phase III failsafe design. A cross-plot of the measurement data in Figure 56 defines the total thickness dimensional deviation from a nominal (based on the 0.013 in/ply) versus the number of plies in the buildup. The plot suggests a sliding scale for the "per ply" thickness allowance as a function of

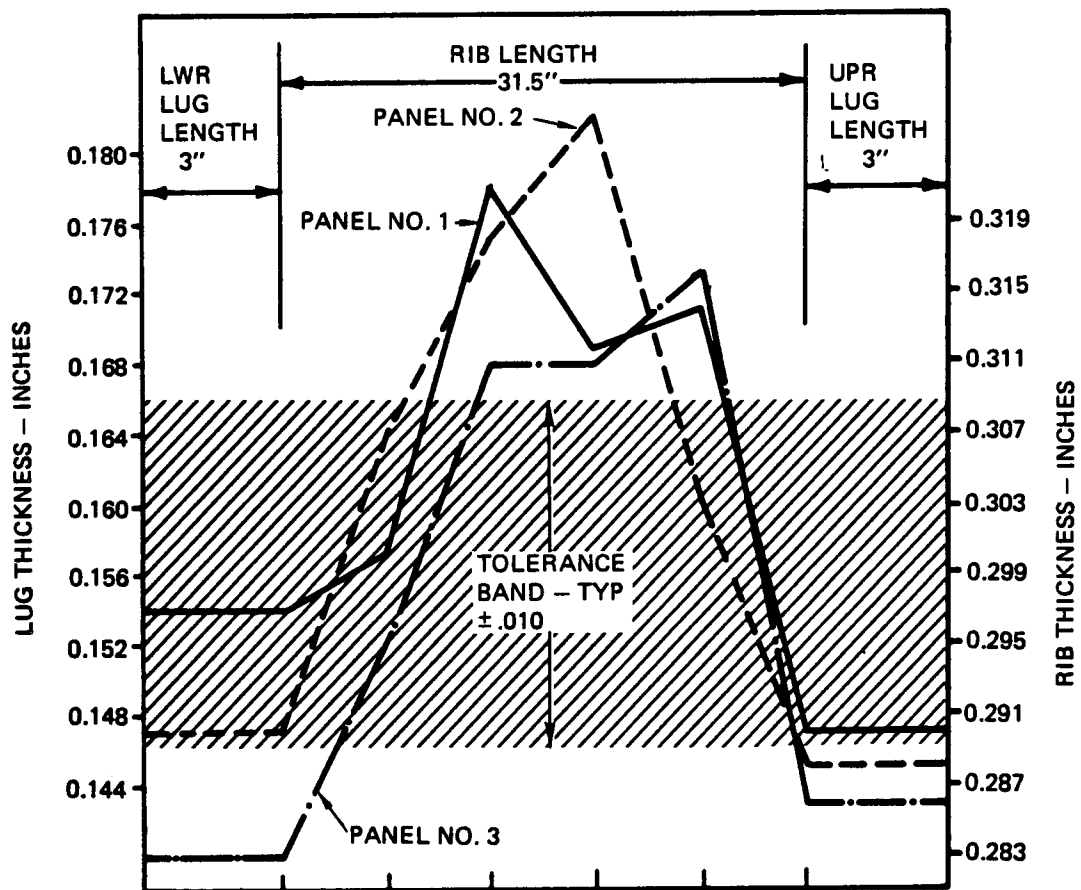
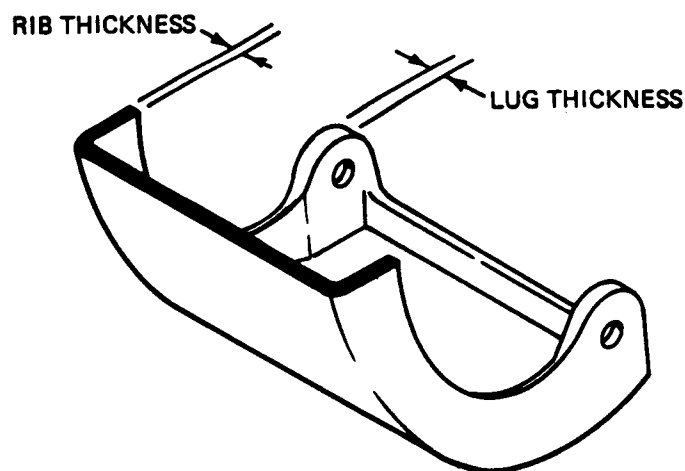
FIGURE 57 LUG AND RIB TOLERANCE AND MEASUREMENTS – COMPARISON OF L.H. RIBS OF COATED PANELS

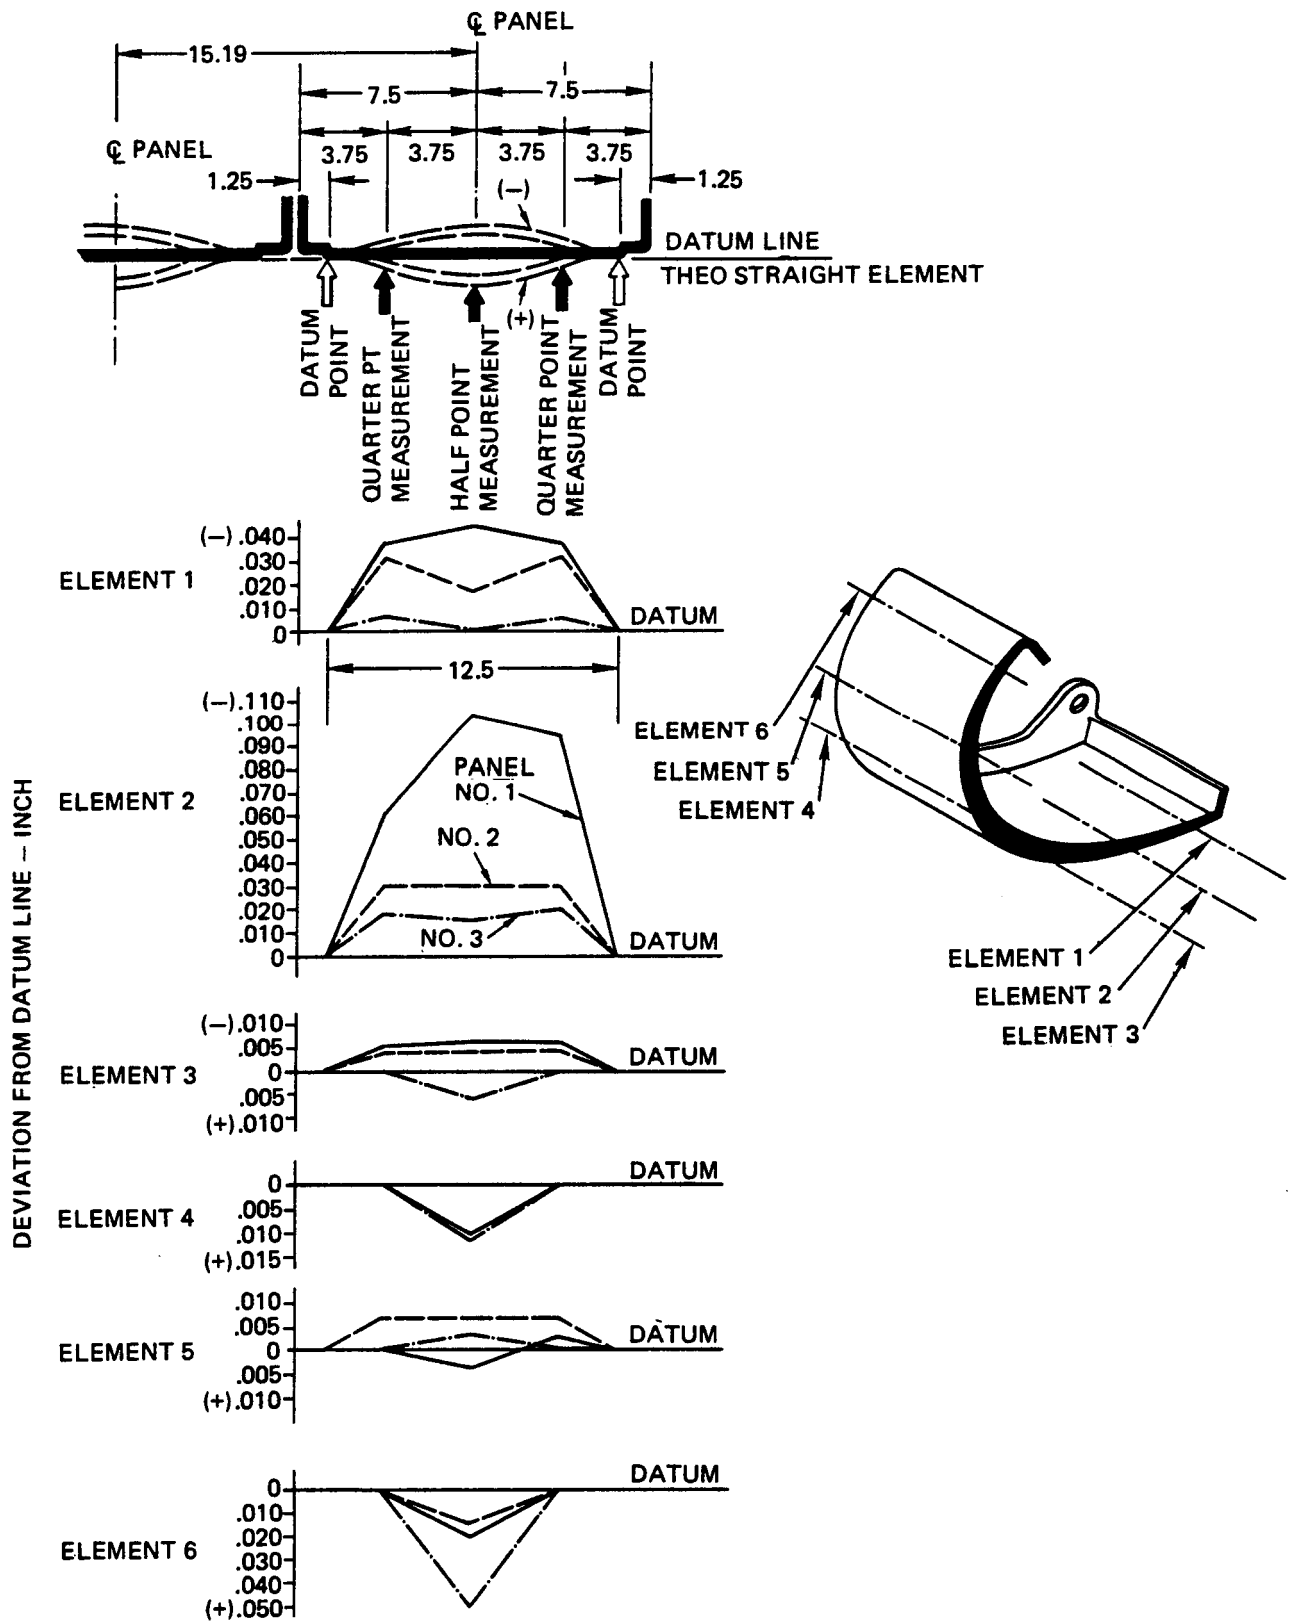
FIGURE 59 PANEL SURFACE STRAIGHTNESS MEASURED ALONG ELEMENT LINES

The data in Figure 59 illustrates the degree of improvement that may be expected as improvements are made in the restraint tooling

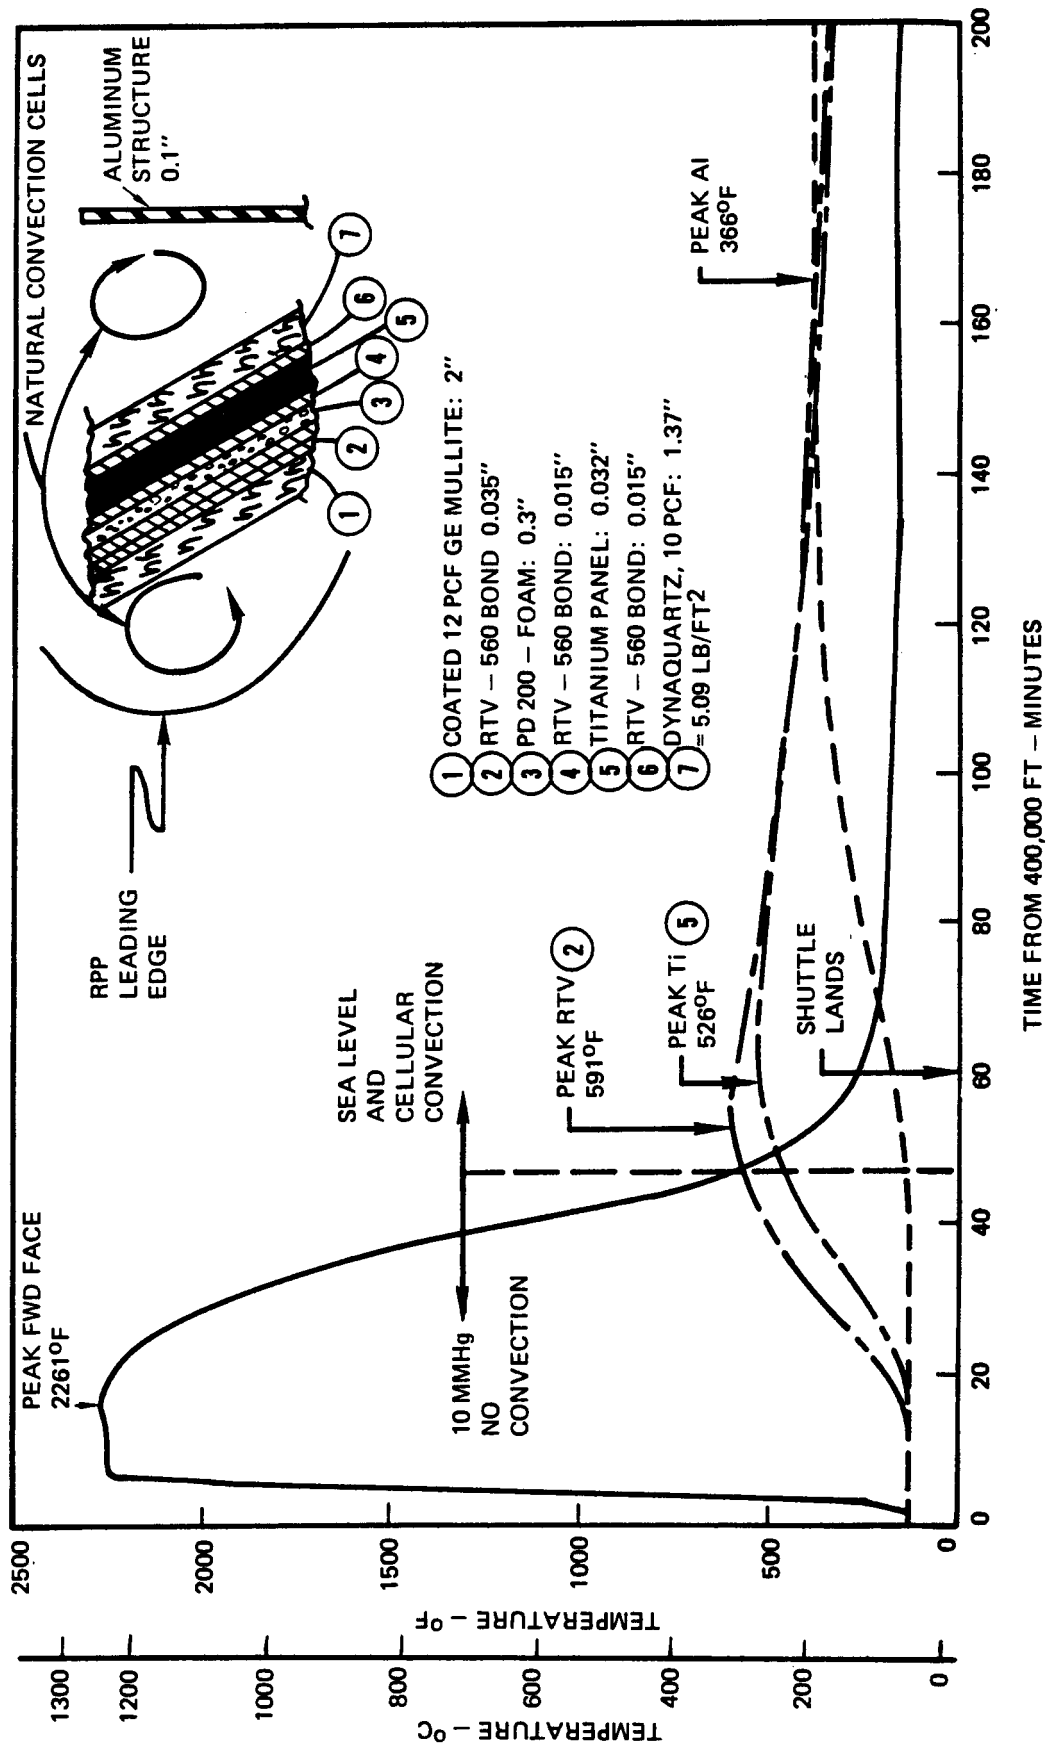
FIGURE 60 TYPICAL TEMPERATURE RESPONSE

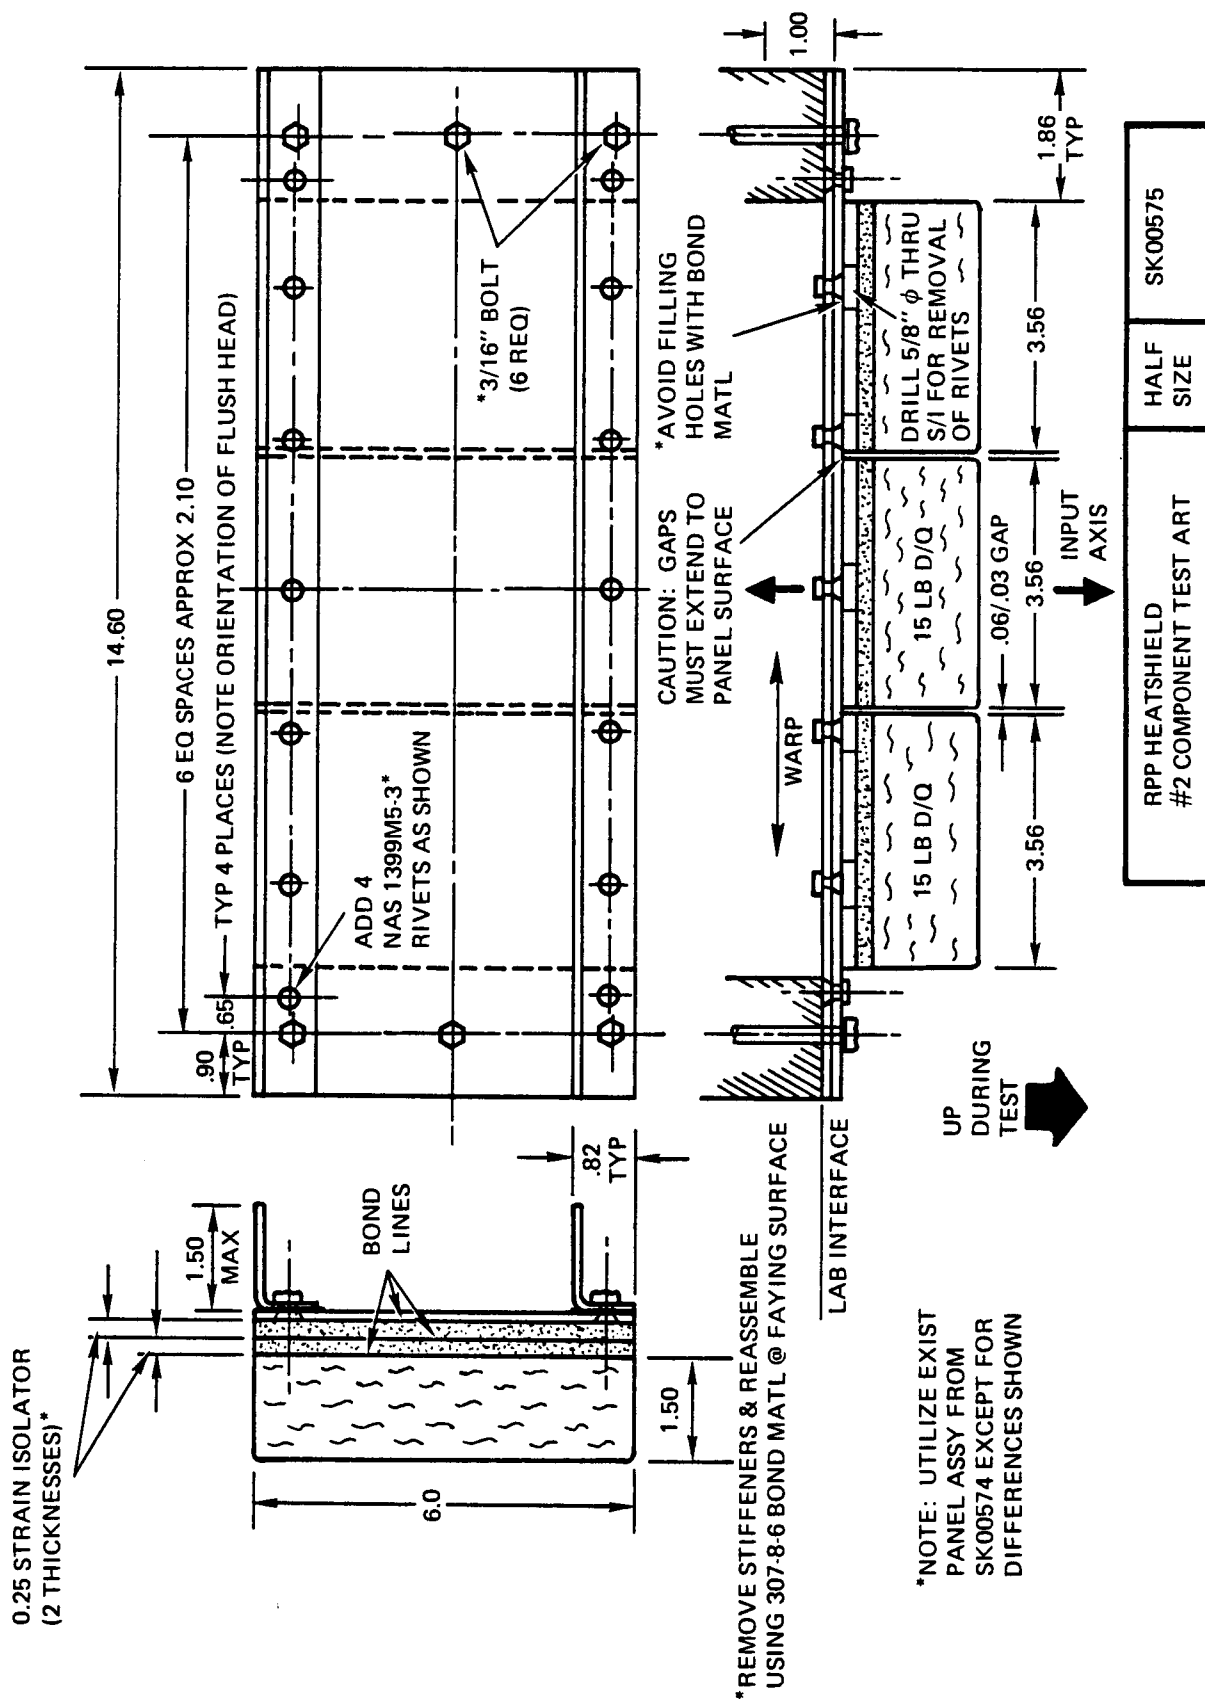
FIGURE 64 SECOND HEATSHIELD TEST COMPONENT

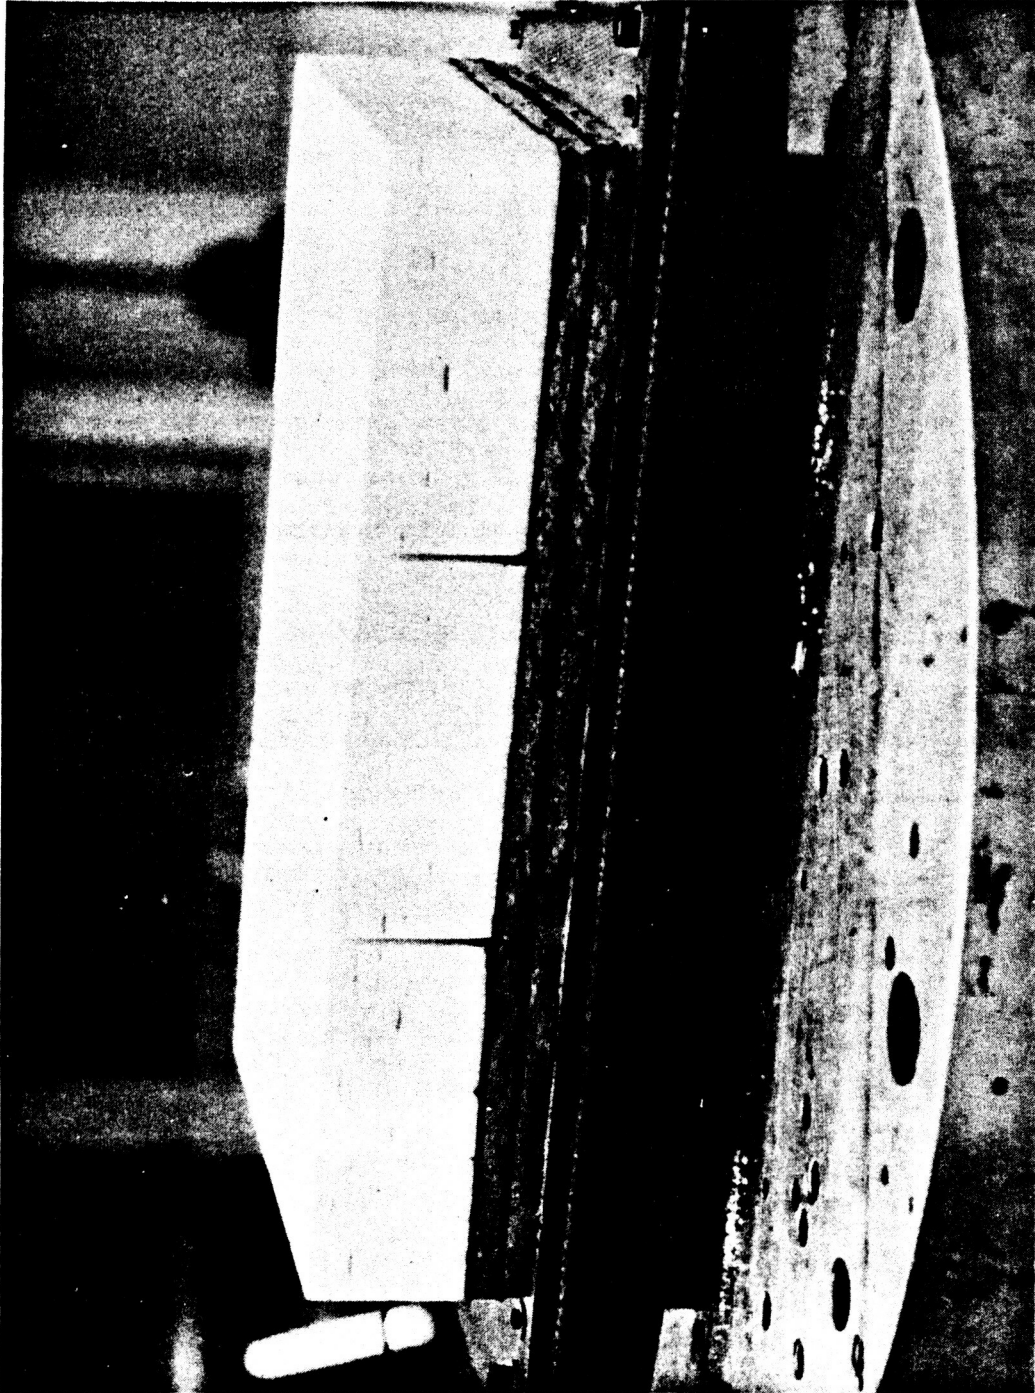
FIGURE 65 SECOND HEATSHIELD TEST COMPONENT AFTER SUCCESSFUL TEST

The significance of this test is that it demonstrates feasibility of a heatshield design in the Shuttle dynamic loads environment.
